Manhole Inspection Summary

Manhole # S71O__002MH

Location Address: **6807 Boston Ave.**

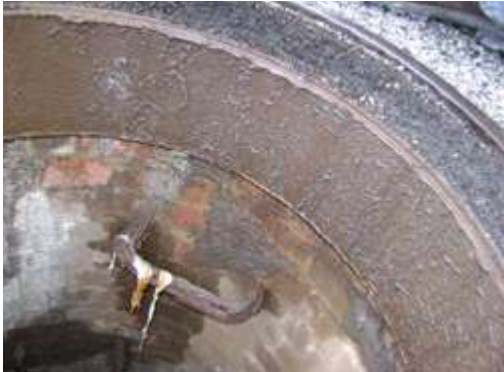
Defect 1

Infiltration under frame

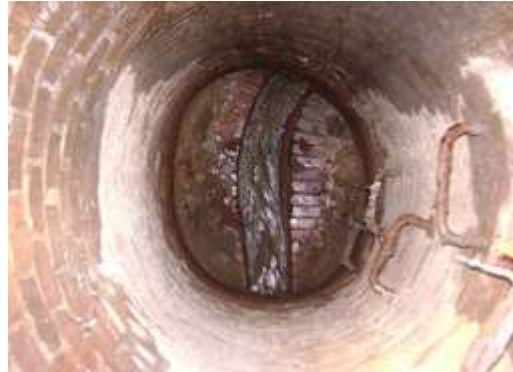
Defect 3

Infiltration on barrel wall in top of photo

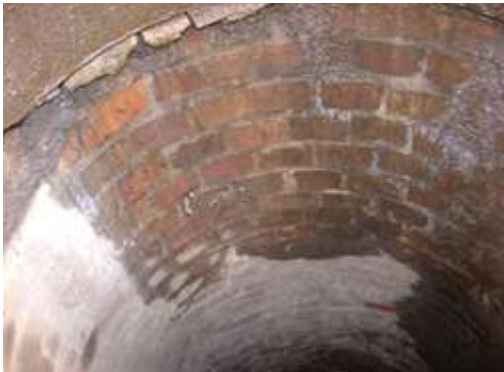
Defect 2

Condition: ☐ Sound ☐ Cracked ☐ Root Intrusion ☒ **Loose Brick** ☐ Deteriorated

Infiltration: ☐ None ☒ **Joint** ☐ Cracks ☒ **Mortar** ☐ Roots ☐ Wall

missing mortar and loose bricks at frame adjustment

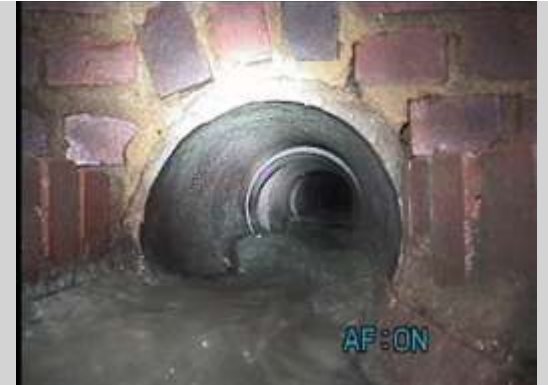
12 O'Clock Outflow

10 in. Circular Gravity Sewer
Pipe Out @ 12 O'Clock

Pipe Height: **9.6** (in.) Rod and Bar (Angled)
Pipe Material: **Clay** ☐ Pipe Lined
Invert Depth: **10.83** (ft.) Flow Characteristics: **Turbulent**
Deposits: ☒ None ☐ Mud ☐ Sludge ☐ Debris ☐ Grease
Silt Depth: (in.) Deposits Extent:
Infiltration: **None** Pipe Seal Cond: **Sound**

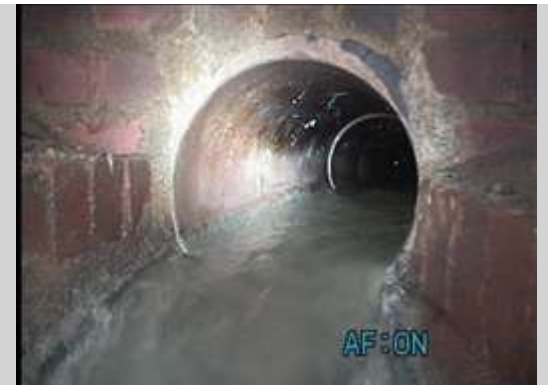
6 O'Clock Inflow

10 in. Circular Gravity Sewer
Pipe In @ 6 O'Clock

Pipe Height: **9.6** (in.) Rod and Bar (Angled)
Pipe Material: **Clay** ☐ Pipe Lined
Invert Depth: **10.50** (ft.) Flow Characteristics: **Fast**
Deposits: ☒ None ☐ Mud ☐ Sludge ☐ Debris ☐ Grease
Silt Depth: (in.) Deposits Extent:
Infiltration: **None** Pipe Seal Cond: **Sound**
